RE: Abbreviated Preliminary Assessment/Integrated Assessment

SITE: Zonolite CO, St. Louis EPA ID # MON000703779

MEMORANDUM

SUBJECT: Removal Assessment for the multiple Vermiculite Investigations; Council Bluffs, Iowa; Kansas City, Missouri; Omaha, Nebraska; St. Louis, Missouri; and Wellsville, Kansas

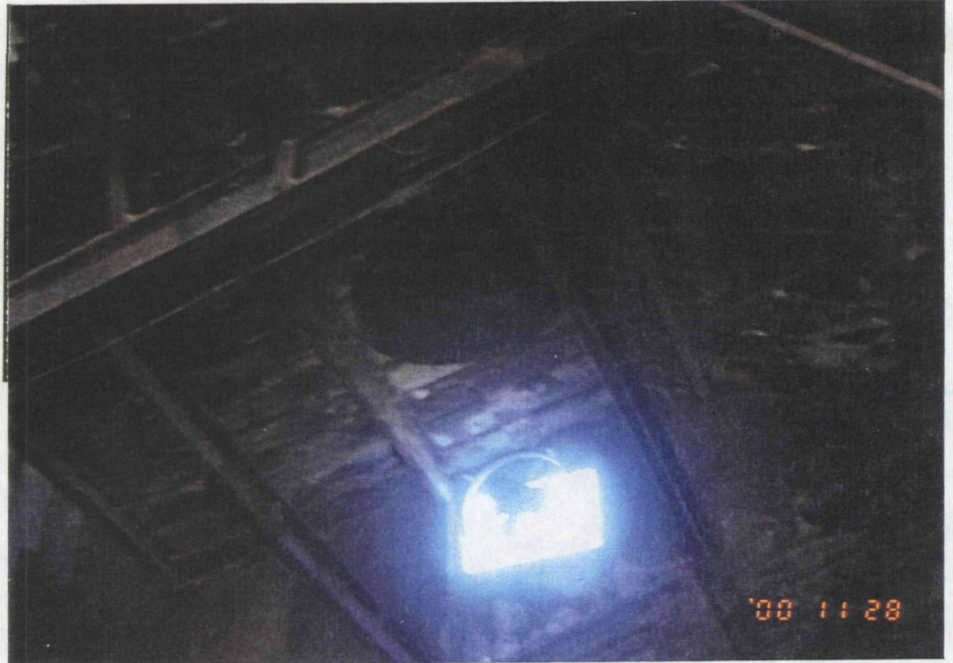
Photographer: Keller
Date: 11/28/00
Time: 1310
Roll: 1
Frame no.: 2
Direction: Up
Comments: Former blast furnace exhaust
hole above floor where sample
KC-002P was collected.

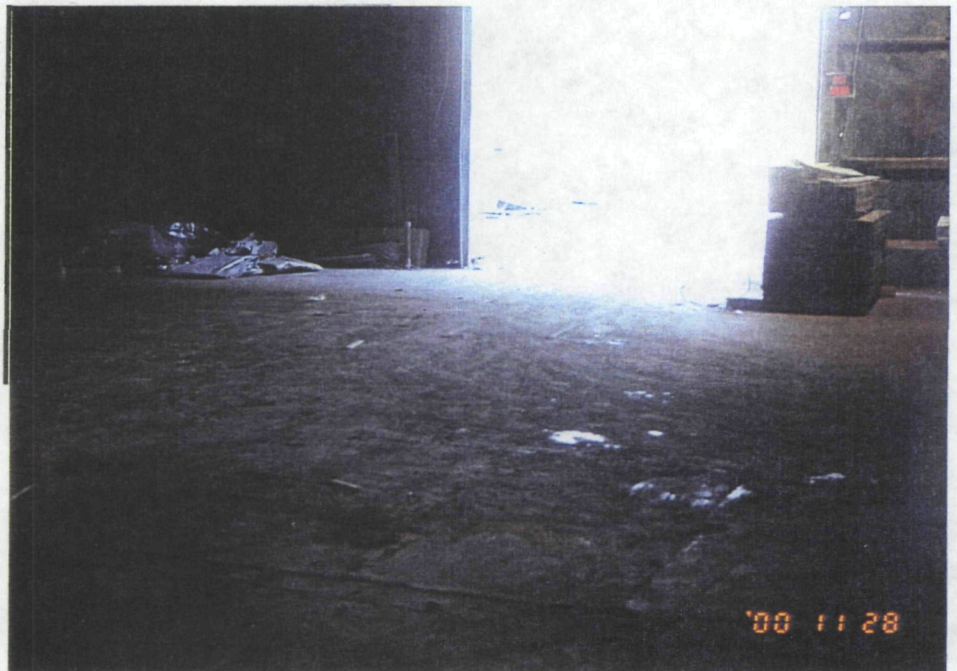
Photographer: Keller
Date: 11/28/00
Time: 1401
Roll: 1
Frame no.: 5
Direction: South
Comments: Floor where sample KC-002P
was collected.

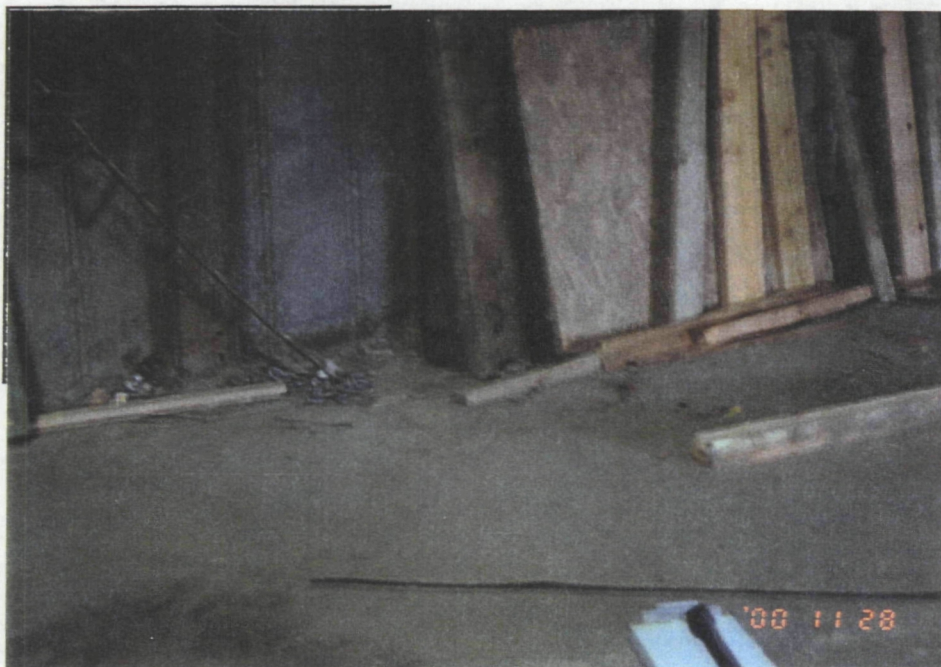
Photographer: Keller
Date: 11/28/00
Time: 1400
Roll: 1
Frame no.: 4
Direction: North
Comments: Wall floor conjunction where
samples KC-001P & KC-001T
were collected

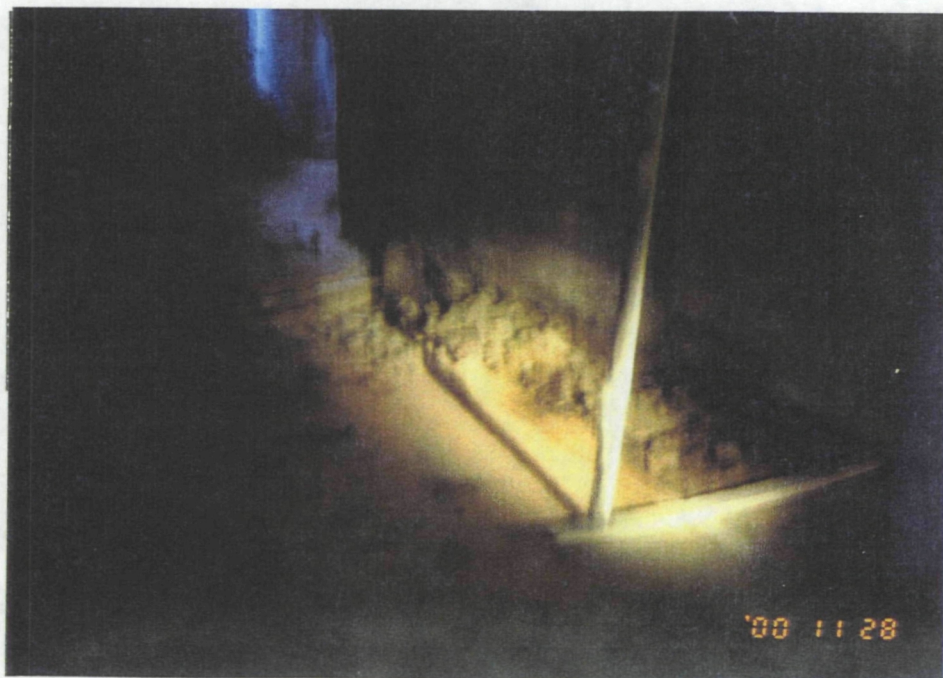
Photographer: Keller
Date: 11/28/00
Time: 1402
Roll: 1
Frame no.: 6
Direction: Southwest
Comments: Wall floor conjunction where
sample KC-003P was collected.

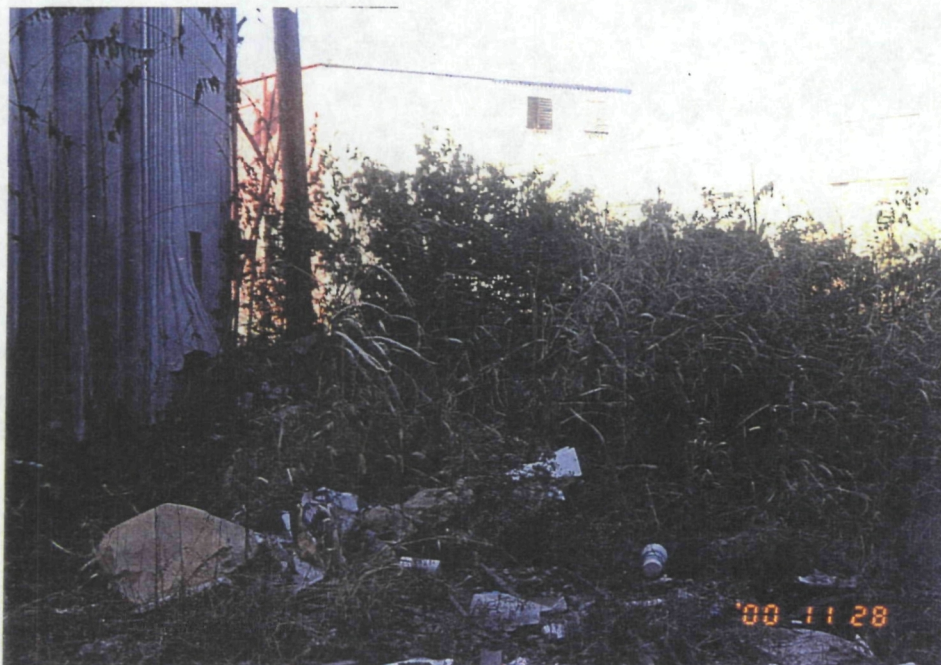
Photographer: Keller
Date: 11/28/00
Time: 1405
Roll: 1
Frame no.: 7
Direction: North
Comments: Debris pile east of building
where sample KC-004P was
collected.

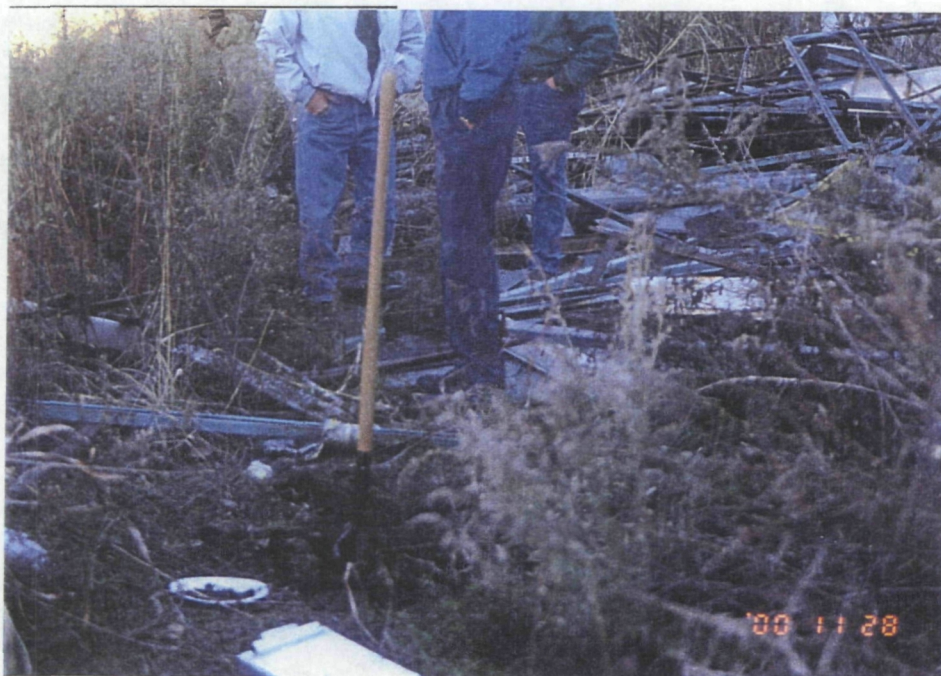
Photographer: Keller
Date: 11/28/00
Time: 1407
Roll: 1
Frame no.: 8
Direction: East
Comments: Sample KC-005P collected north
of the building.

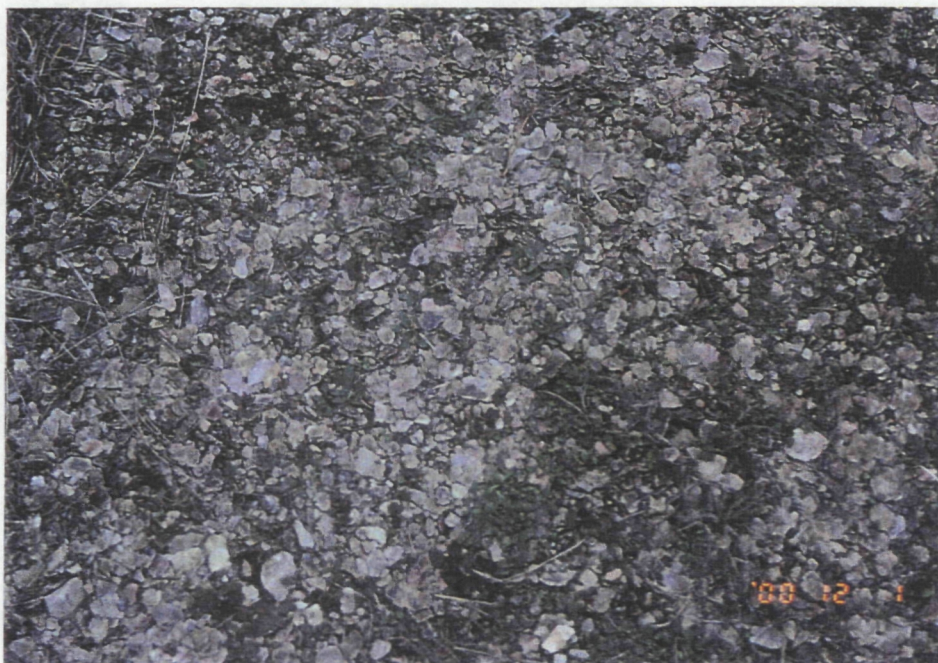
Comments: Mica pile north of building
sample W-001P & W-001T

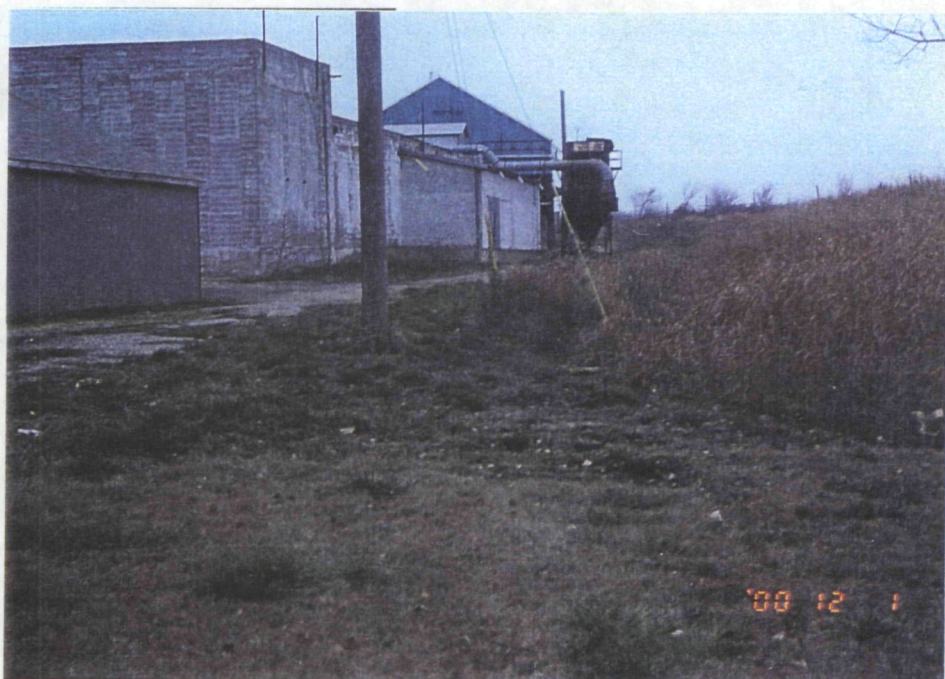
Comments: Mica pile with building to the
south and creek to the north.

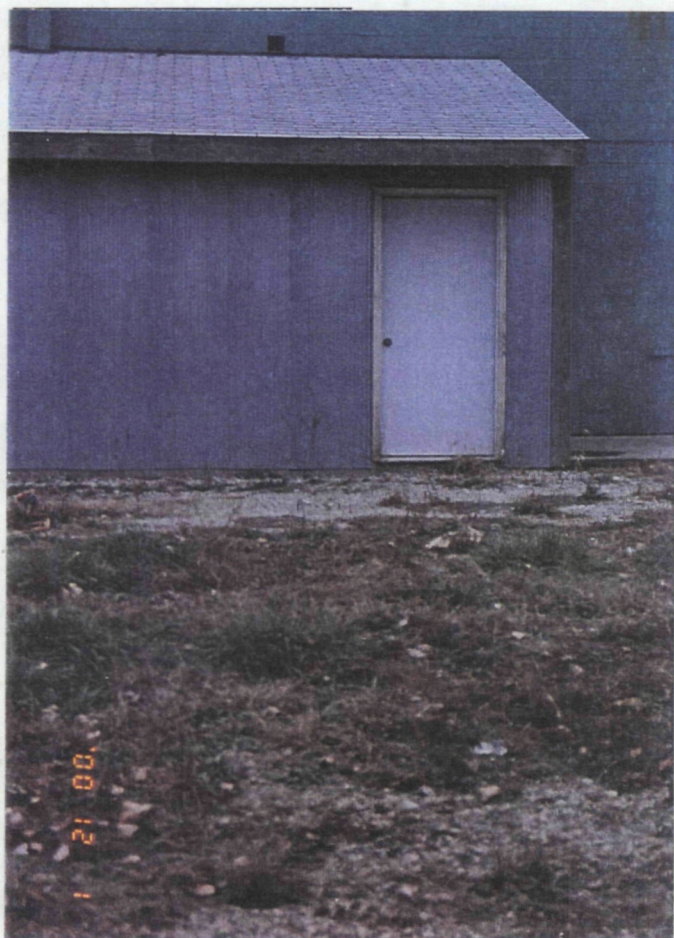
Comments: Building with large mica pile in foreground

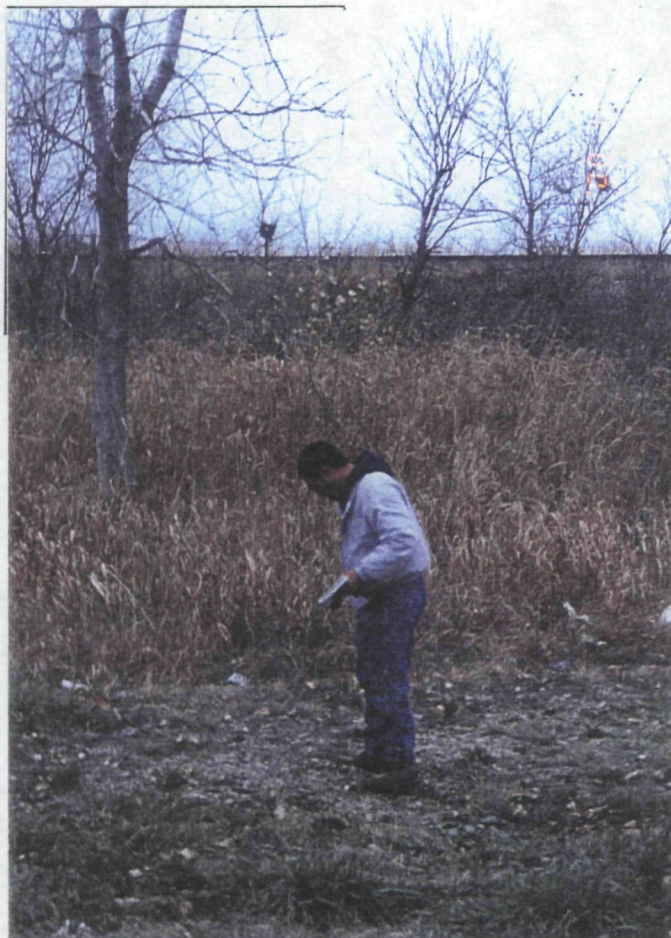
Comments: Mica pile with stream and railroad in background

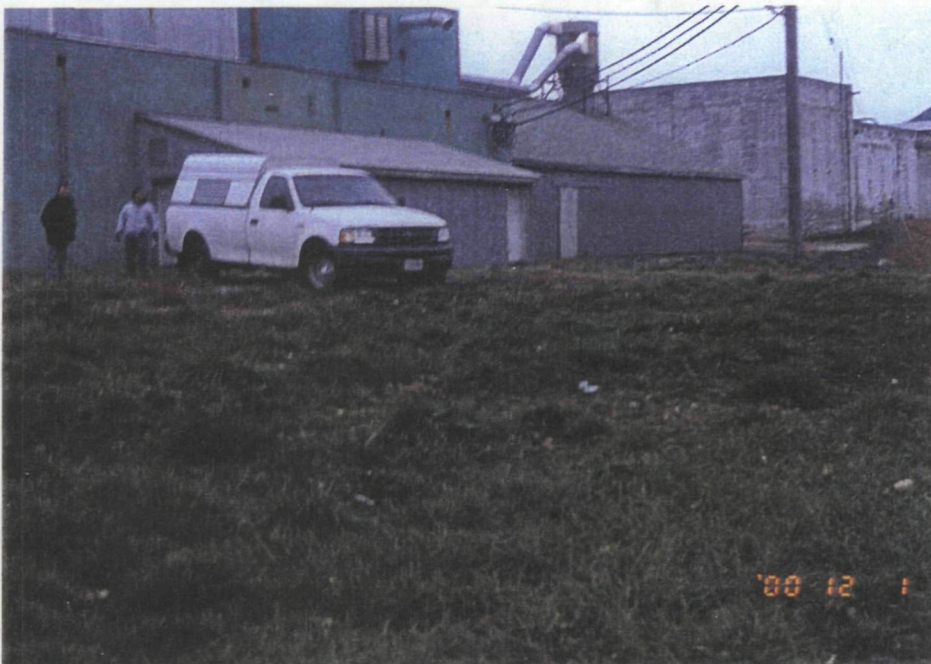
Comments: Field Northeast of building
sample W-002P

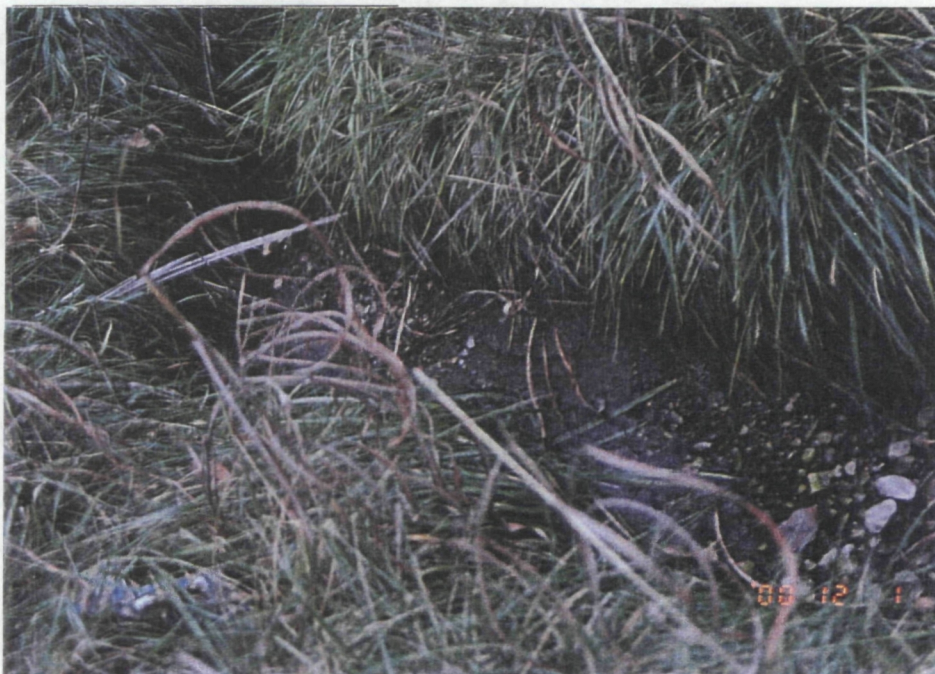
Comments: Stream north of building
sample W-003P
